# A Practical Assessment of the X-Ray Rooms Efficiency in Iraqi Hospitals Using a Detector and Radioactivity Level Sensor

Shahad Ibrahim Nawaf Hamadi, Ahmed Majeed Saleh Fayhan,  
Noor Al-Huda Ahmed Ayed Fayyad, Noor Subhi Abd al-Ghafour Nassar,  
Duha Rahim Falih Hassan, Abdul Ghafour Mohammed Abdul Ghafour Askar  
University of Fallujah College of Applied Science Department of Medical Physics/medical optics

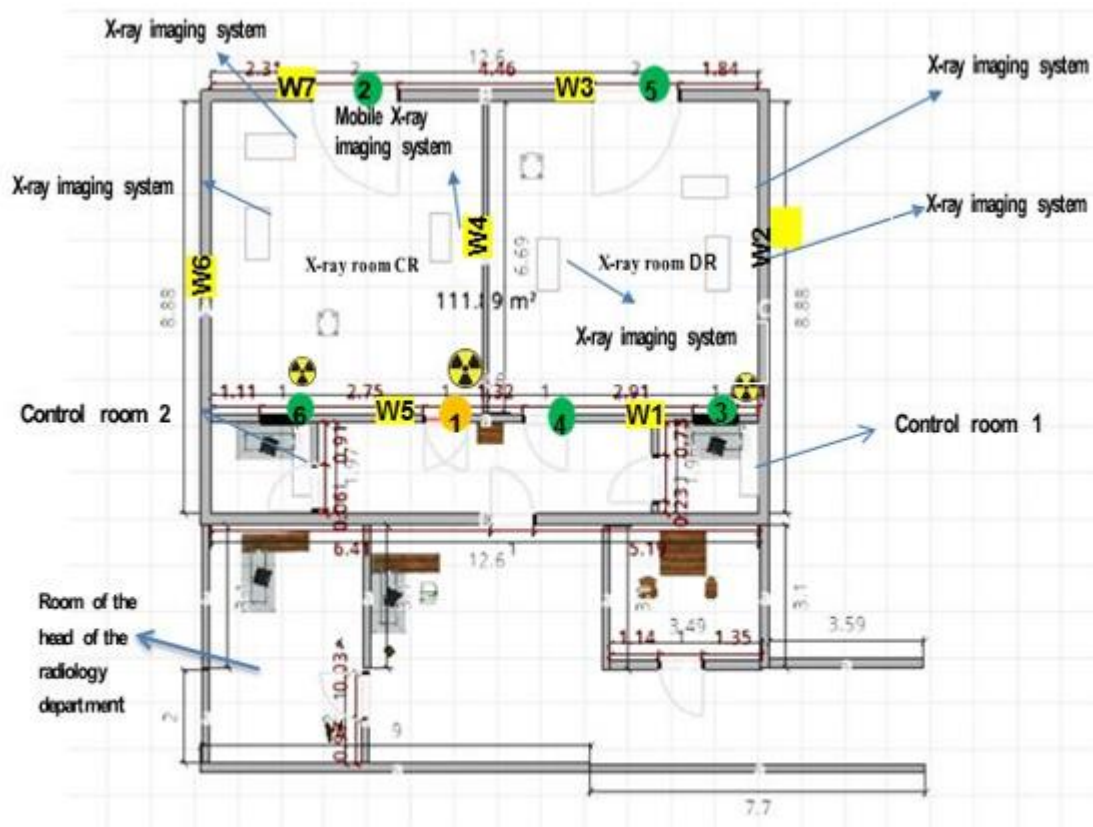
CR room (0.80  $\mu\text{Sv/h}$ ) and the lowest leakage rate at the window of the control room of the DR room (0.16  $\mu\text{Sv/h}$ ). The design of the two rooms matched the international designs of X-ray rooms, and they were covered with lead and spacious, and the number of workers rotated well. We drew charts for the patients' data. The numbers were large during the day, but they did not mention their ages, just the names of the patients, and thus we did not know the age groups being examined.

**FIGURE 2.** shows the design of X-ray rooms and places of radiation leakage (F.T.H).

Disadvantages in these rooms: Directly above the second chamber (CR) there is a laboratory. Examiners do not wear protective jackets due to their heavy weight. There is a hole under the door in the second room (CR) that led to a leak.

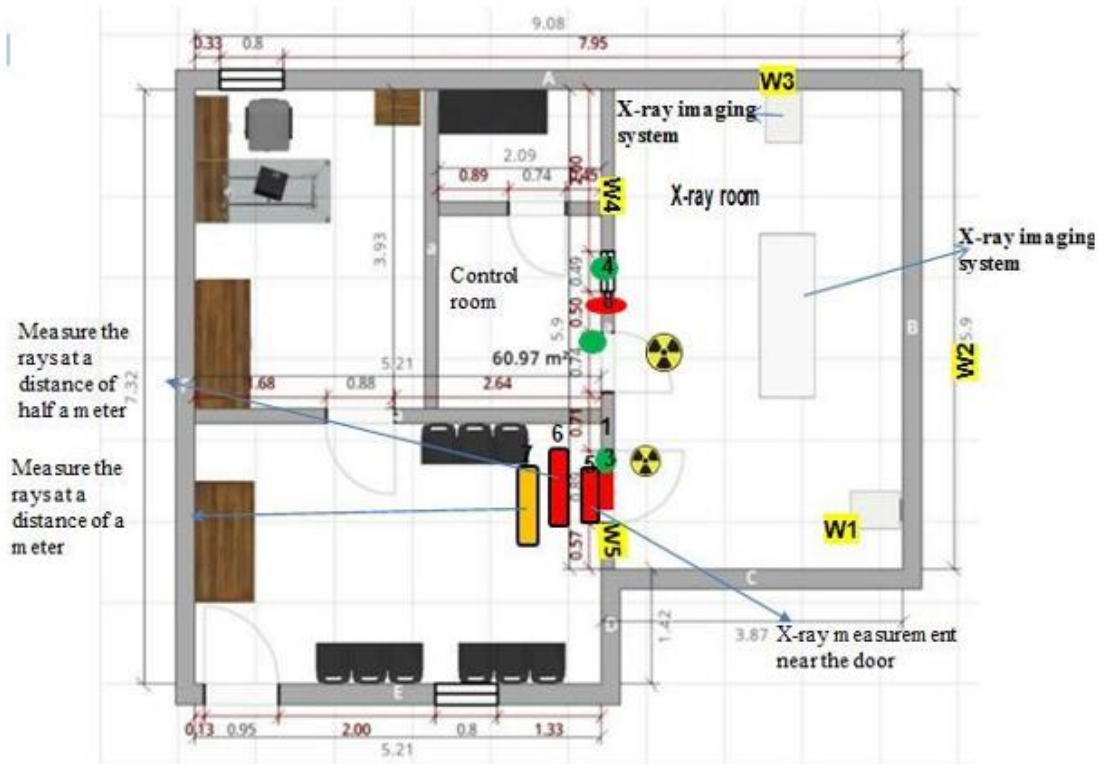
FIGURE 5. shows the design of the X-ray room and the places of radiation Leakage (consulting).

Disadvantages of these rooms: Examiners do not wear protective jackets due to their heavy weight. The consultation room is chaotic and its building is very old, which led to measuring high leakage rates The device identification card is free of specifications. A loophole in the consultation room. The presence of a gap in the consulting room in the door handle. The presence of an opening above

the door of the consulting room in led to a large percentage of leakage. The presence of an opening under the door of the consulting room in led to a large percentage of leakage.
